ST ANDREW'S CHURCH, WEST DEREHAM

ASHLEY COURTNEY RIBA AABC LTD

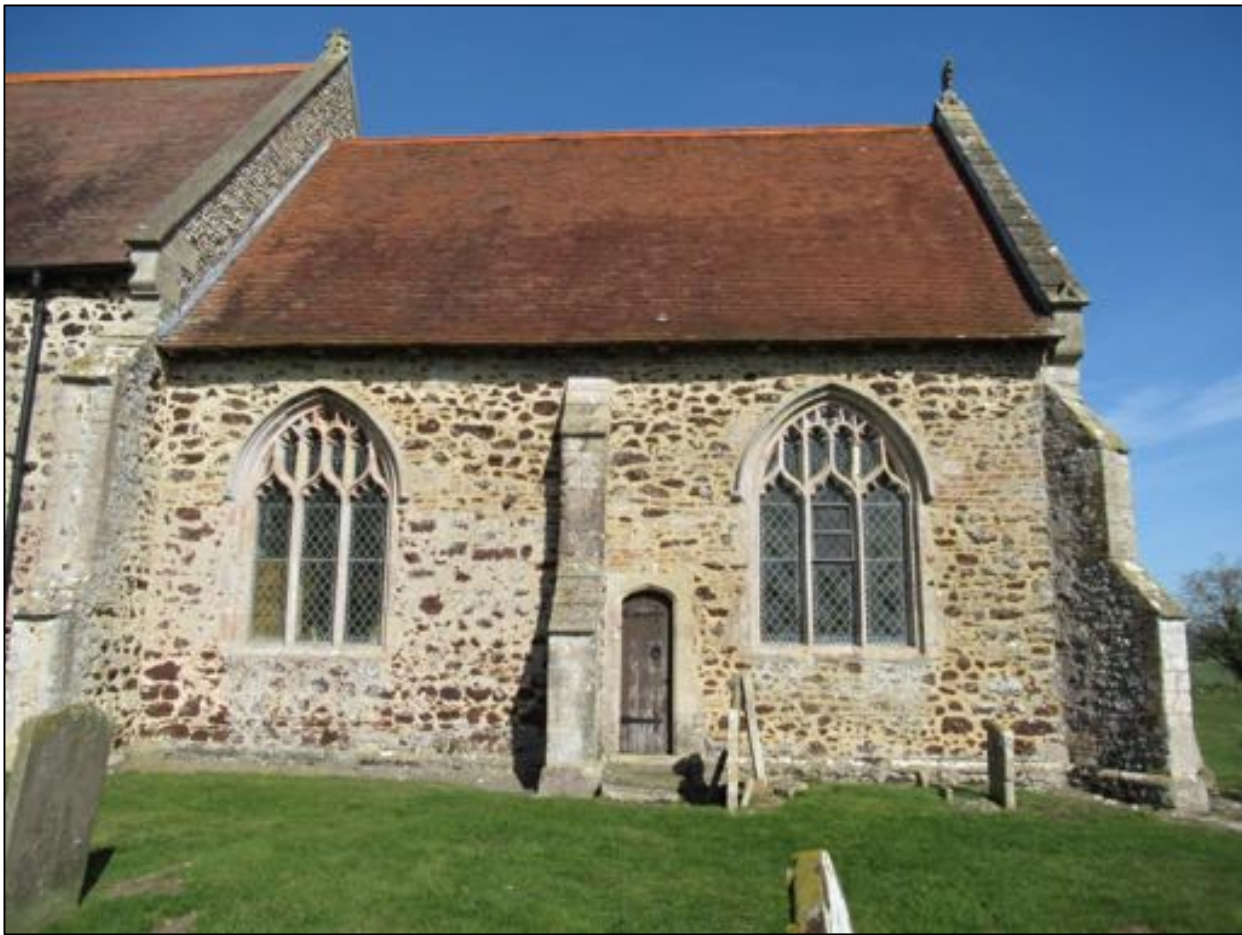
Chancel - south elevation, showing extensive cement pointing to the rubble walling

Once the east window had been rebuilt we turned our attention to re-rendering the chancel. It was evident from a visual inspection of the remaining renders they were lime rich, with an even softer earth consolidated bedding mortar behind. It was clear to me that a hot lime render, made by slaking quicklime on site, was to be used as this traditional method of making mortars produced a lime rich mortar. Not only this, the pore structure of a hot lime mortar matches closely that of a water molecule and thereby creates a mortar of high capillarity. This in turn readily allows water to move to the evaporation face of the render and thus dries out the fabric more quickly. As recent research has shown, a render acts like a poultice drying out a rubble wall so much more effectively than one that is merely pointed.

A further reason to re-render the walls became evident when we removed the cement pointing as it revealed bedding mortars with many cavities (as is often the case), meaning water can easily penetrate through the fabric. Merely pointing the wall is very difficult at the best of times, and to try and point around such irregular and porous rubble as the ironstone we encountered here would have made it impossible to make the fabric weathertight.

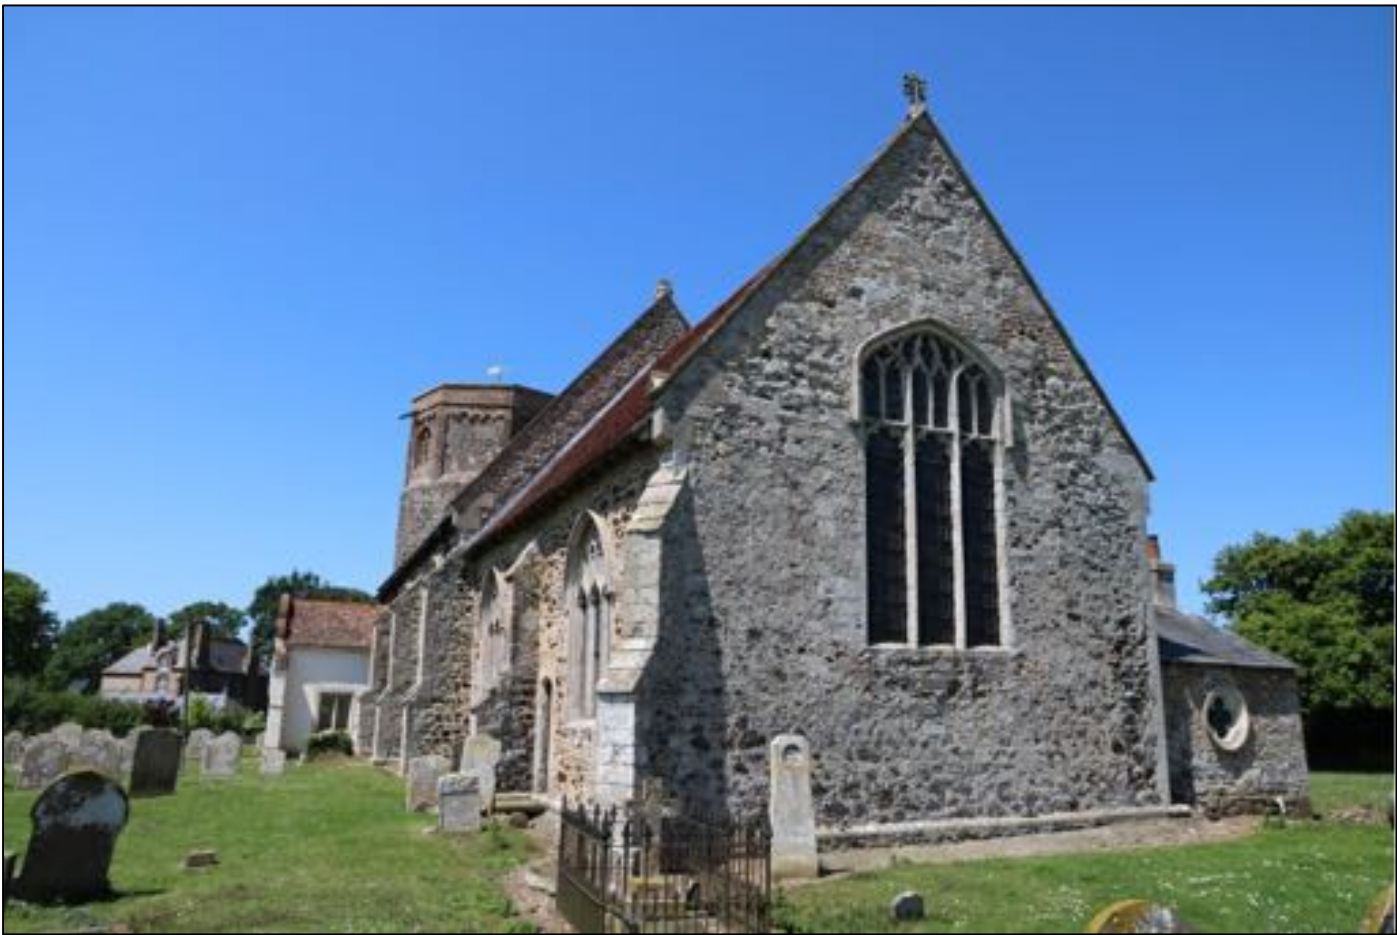
Chancel - east elevation, showing remnants of render and a lot of C19 brick replacement to the gable

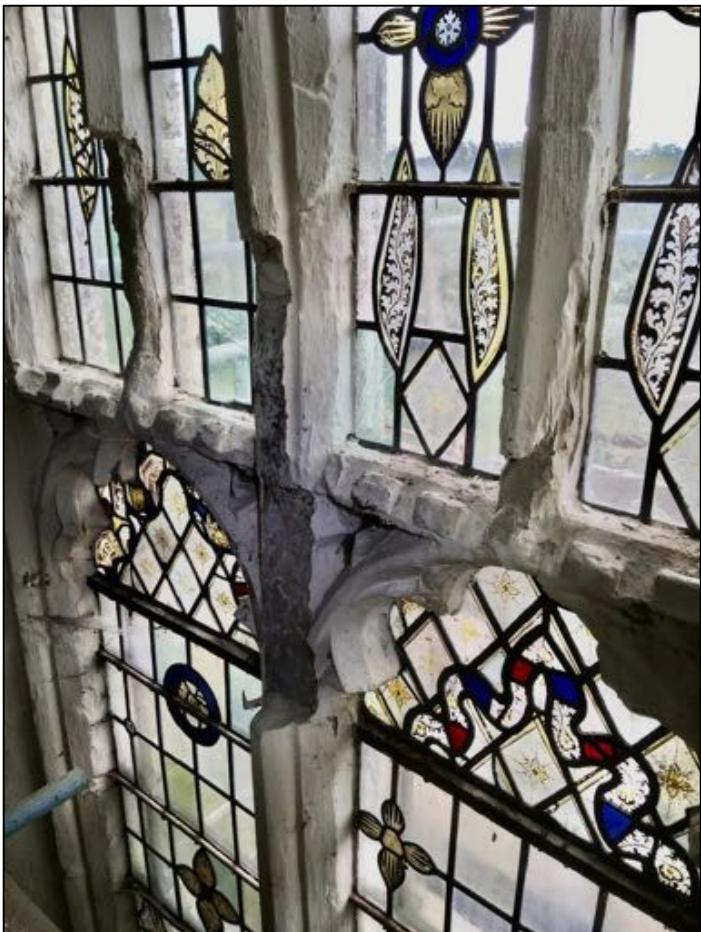
Investigations revealing the poor condition of the east window, and the stress it was putting on the medieval glass

We obviously had to repair the east window first, and we thought initially that this would be a case of stone indent repairs, but once scaffolding was installed and a closer examination carried out, it was apparent that this C15 clunch window had been patched up many times before. It transpired that there was an awful lot of C19 brickwork and mortar repairs, and what remained of the clunch stonework was really very friable and rotten. We were then faced with the need to apply for an emergency faculty to take the stain glass window out, and to replace all of the tracery masonry. It is a great shame we can now no longer obtain local clunch, and after discussions with the DAC we reluctantly chose Hartham Park Bath stone. Our next challenge was to resolve the geometry of the window as it had twisted and bent out of shape over the centuries. This was no easy task as the stain glass had been made to fit the existing tracery and there was little scope to alter the glass. We were, however, able to make some small adjustments, and the masons did a brilliant job of setting it out and installing it, followed by the glaziers. We finished off the window masonry with a protective coat of limewash, bringing both new and old stone into a unified whole.

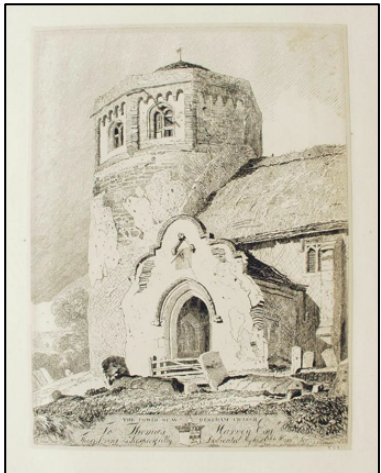
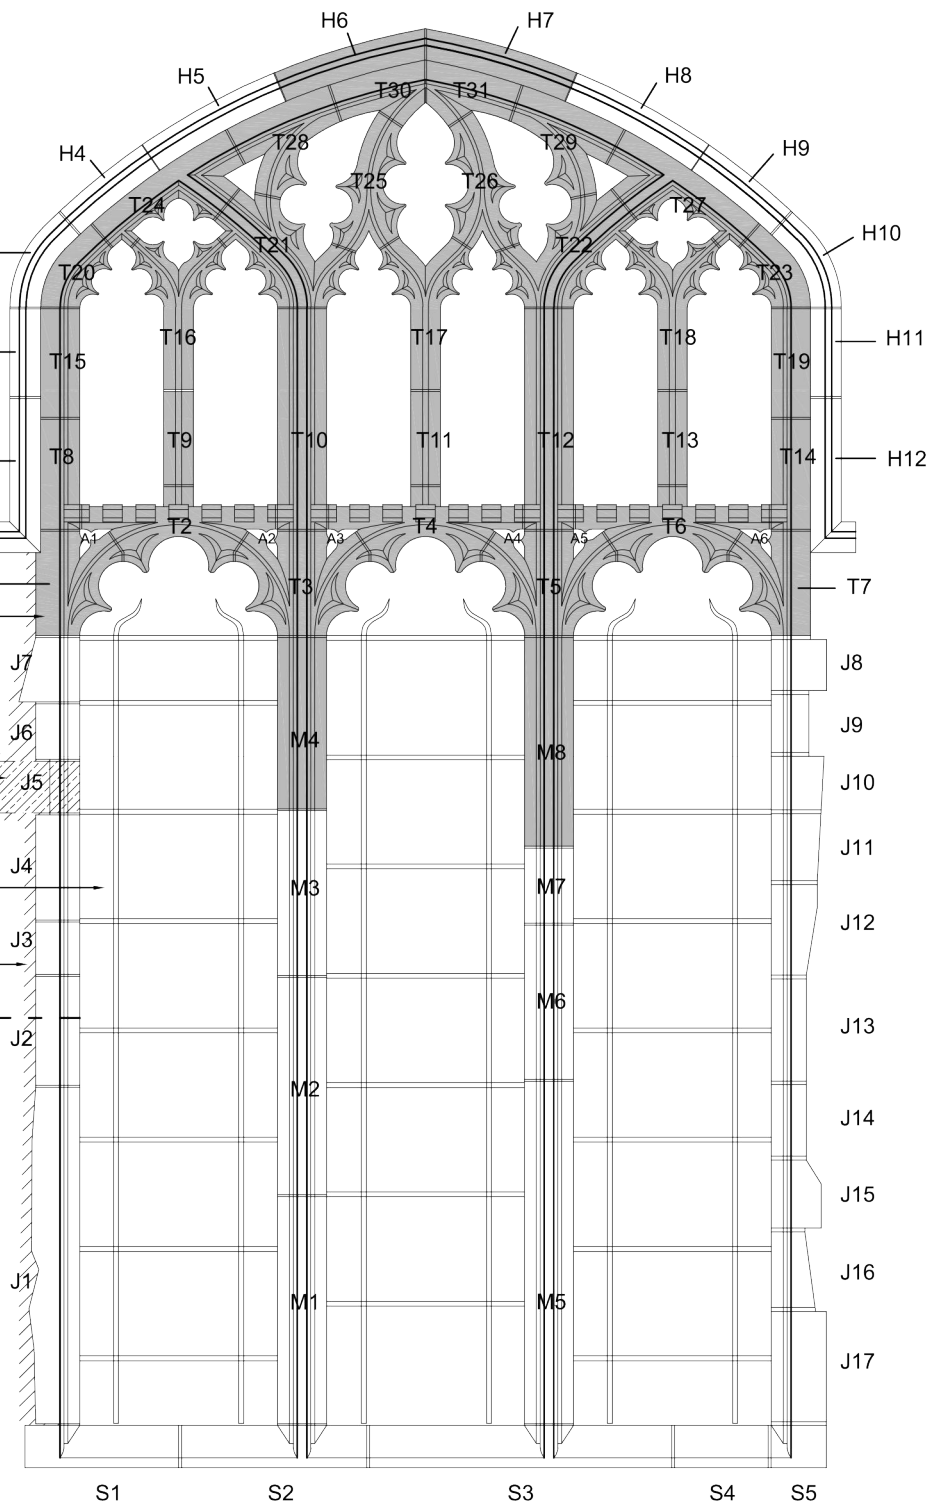
Drawing of the east window showing it all square and true, and the extent of full stone replacement following our investigations

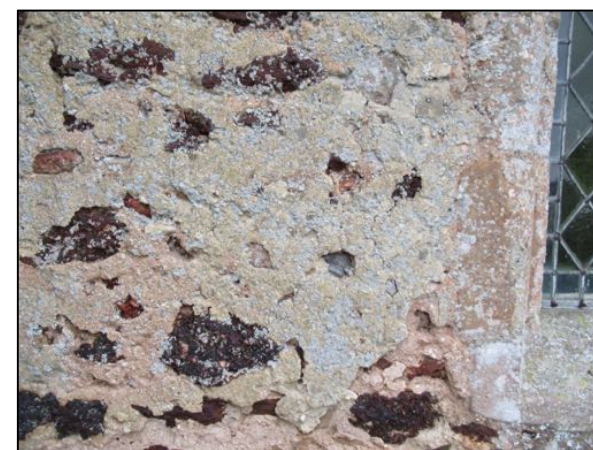
Existing evidence of render base coats with exposed porous rubble walling, all covered in lichen adding to inexorable decay

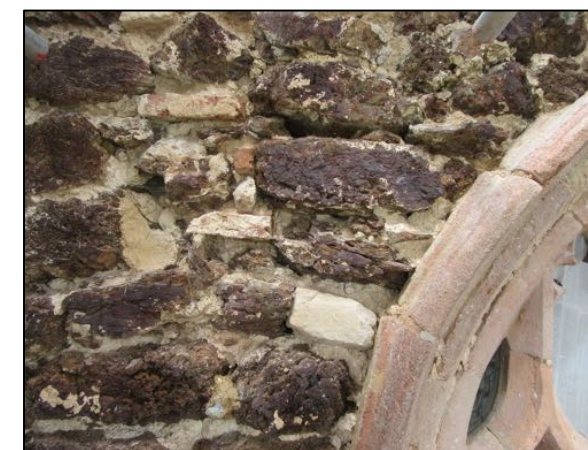
Condition of rubble walling once cement pointing was removed revealing many cavities allowing water to pass deep into the wall, saturating the masonry, and without being able to dry out effectively

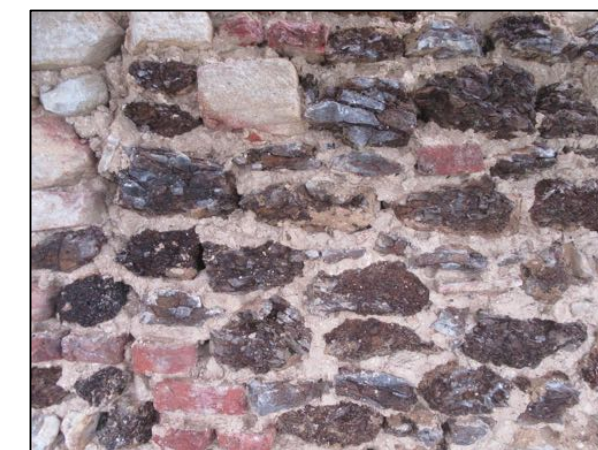
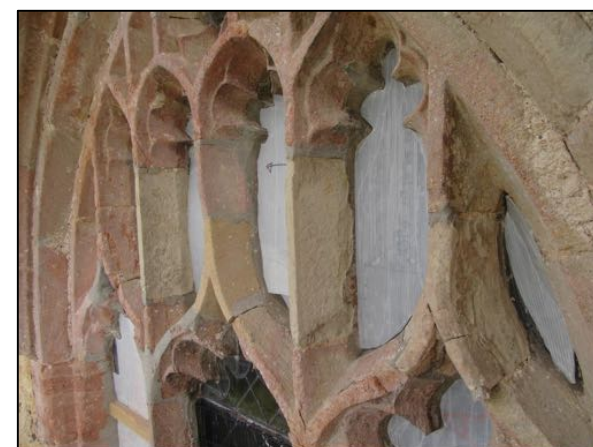
Poor condition generally of chancel windows and buttress dressing following cleaning, showing multiple fractures, loss of details, previous cement repairs and erosion from lichens and weather

We also had to remove all of the mirco-biological growth, not only from the rubble, but also the stone dressings of the buttresses and the remaining window masonry. This was done by applying an algacide and then steam cleaning. It was very surprising to see how bad the state of the stonework was to both the buttresses and windows. The appearance was rather pink and we wondered if there had been a fire. The condition was such that stone piece repairs were required by the masons as well as general repointing. Furthermore, additional nano-lime consolidation, micro-filling of fractures, and mortar repairs were also necessary by a specialist conservator, who also restored the profiles to the window masonry so they could properly shed water once again.
