S. Helen's, Austerfield.
as Restored 1898.

C. Hodgson Fowler, F.S.A.
 Architect

S. Helen's, Austerfield
before Restoration - 1897.

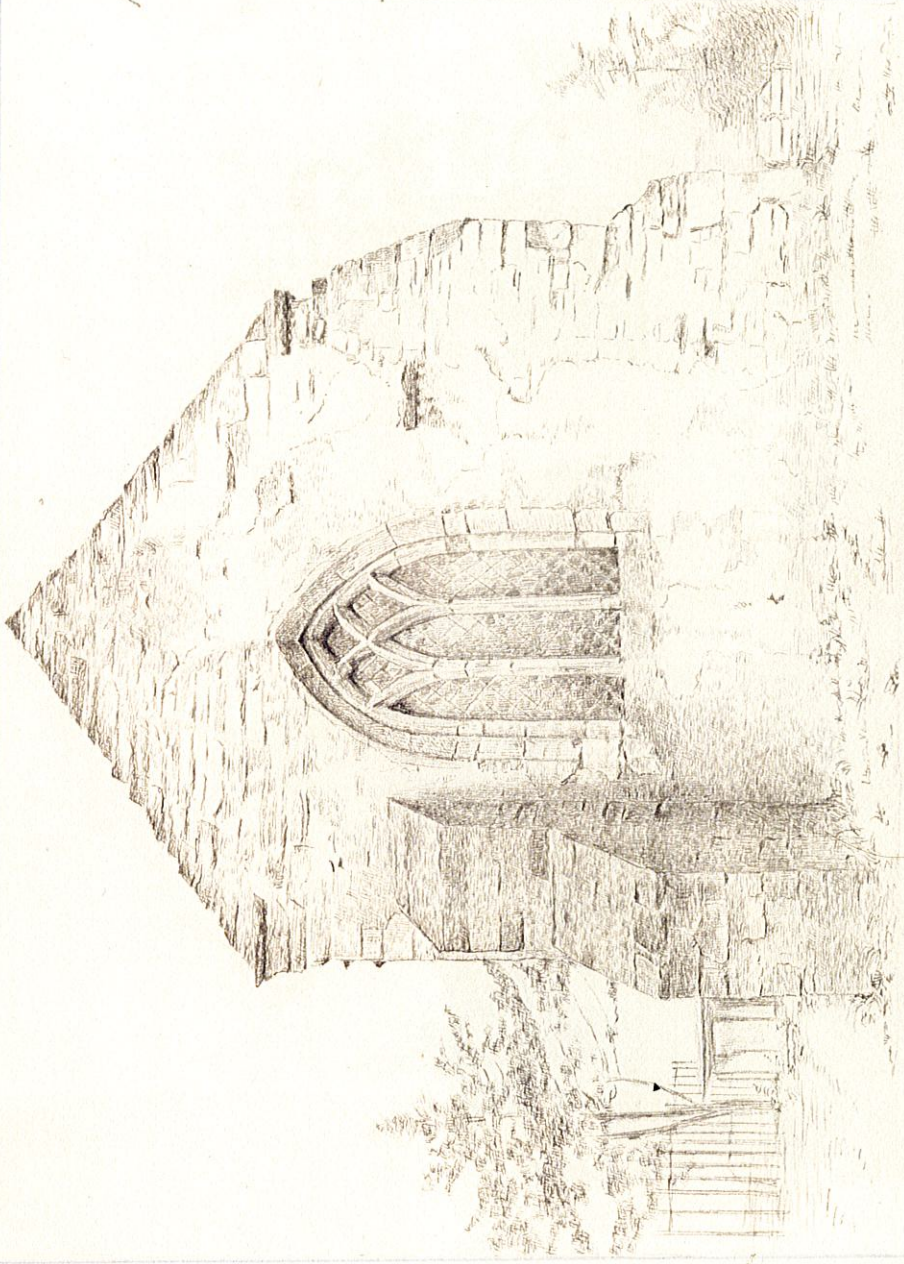
Old East end wall which was rebuilt, being too ruinous to stand **T**he buttresses are quite modern **T**he window has been re-set in the new East wall

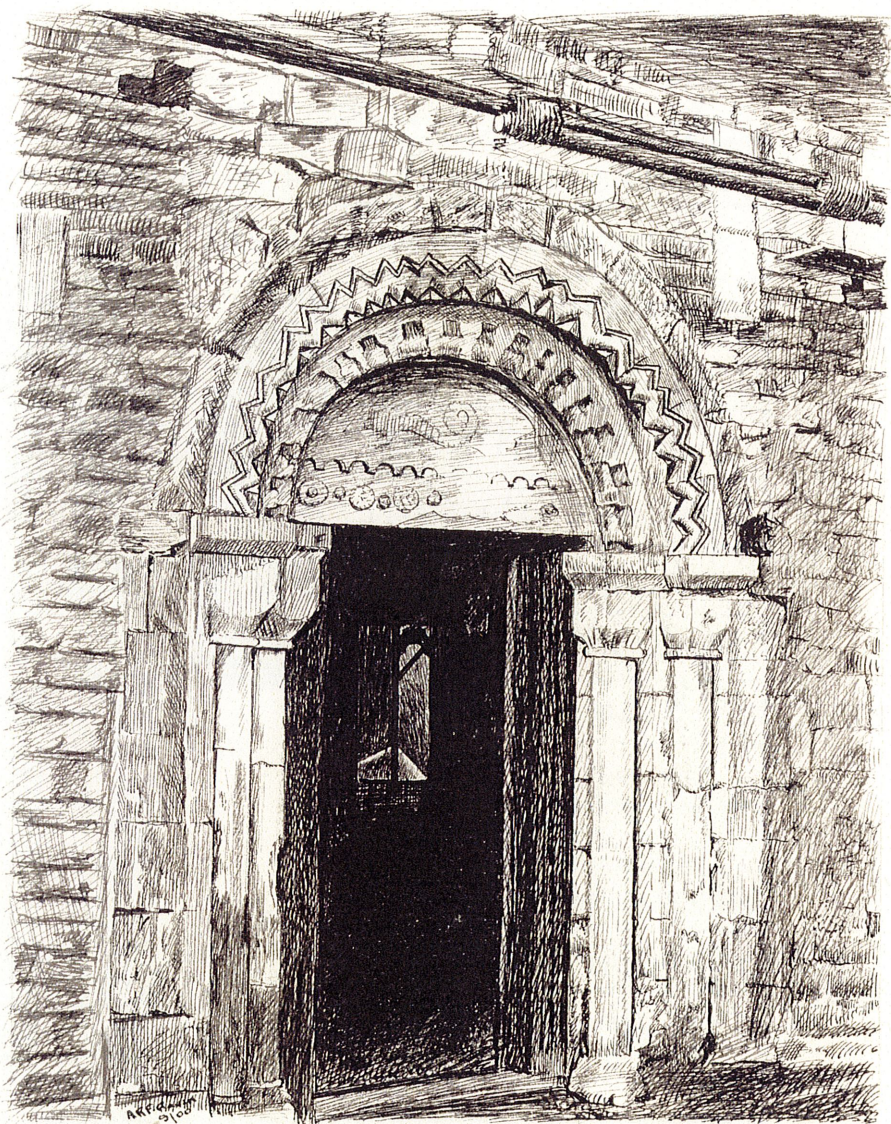
South doorway, drawn after removal of porch
during restoration For description see page 73.

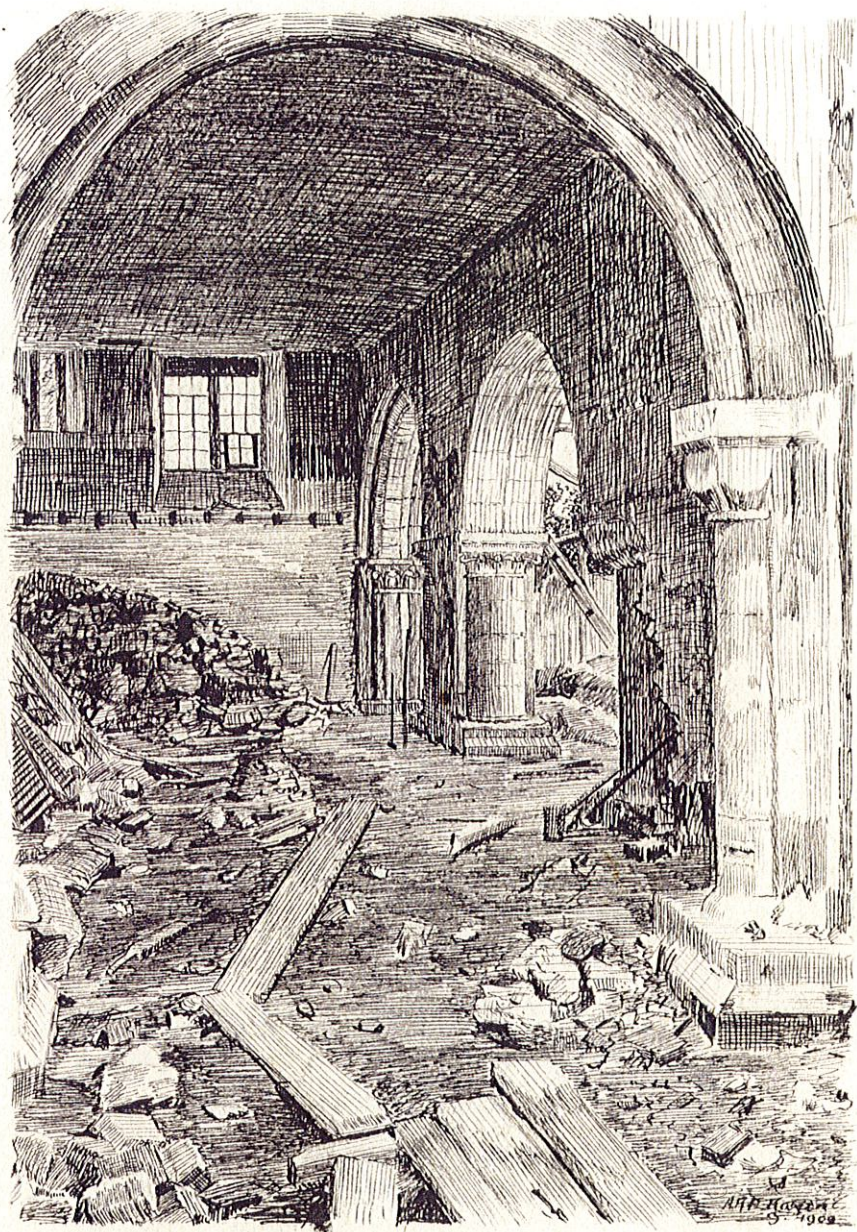
Interior after removal of gallery and interior fittings, and after the rubble which filled up the hidden arches had been removed from two of them. Observe the old window on left, with top hidden by plaster; also the square window cut to light the gallery doubtless destroying an ancient window similar to that on the left
