ST ANDREW'S CHURCH, WEST DEREHAM

ASHLEY COURTNEY RIBA AABC LTD

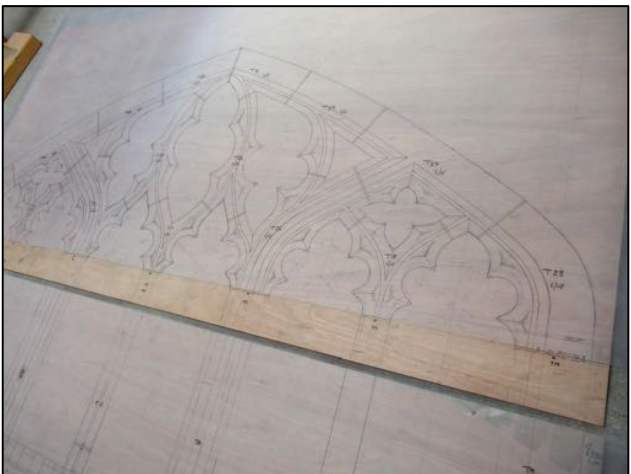
Full size drawing of the tracery by stone mason reflecting more accurately the distorted tracery

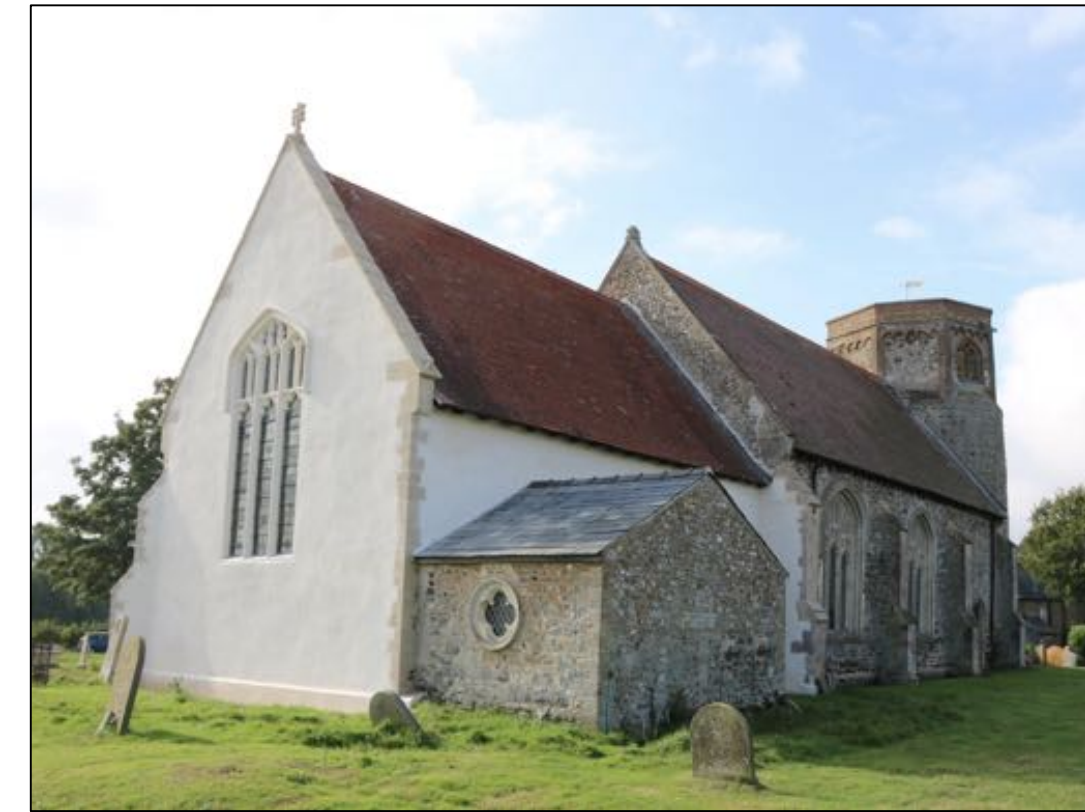
Completed chancel

The works have undoubtedly changed the appearance of the church, but I think the result is very close to how the chancel originally looked, and is not at all unattractive. In restoring the traditional lime finishes to a rubble wall construction, the fabric is properly protected as originally intended, and the internal environment made more comfortable for everyone using the church for many years to come.

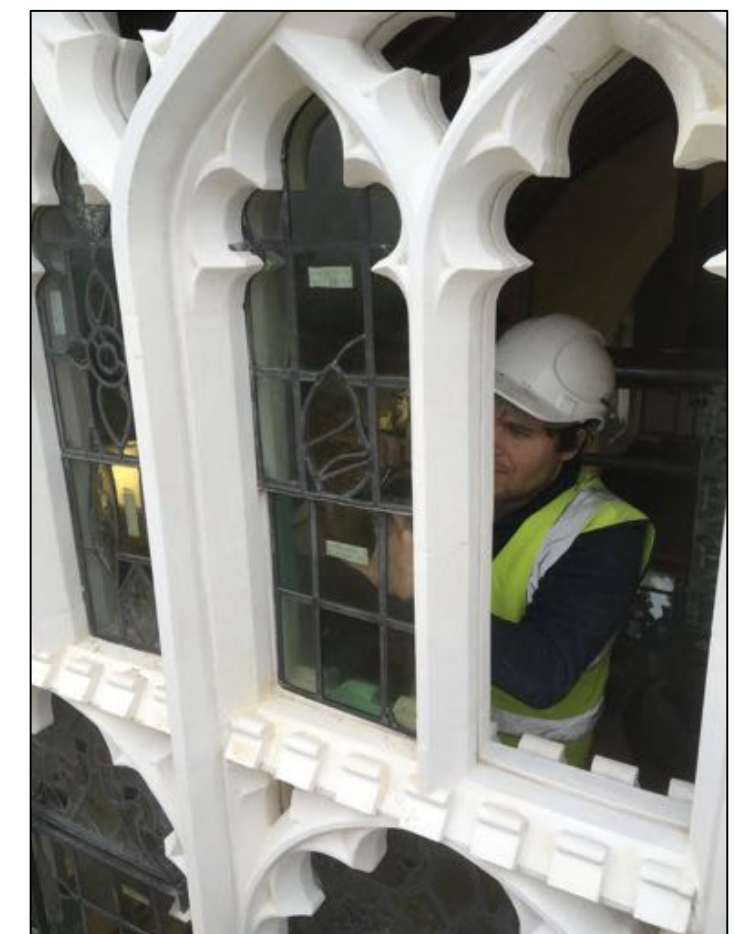
Conservation of window masonry in progress, by Gem Conservation before shelter coating

We also had to remove all of the mirco-biological growth, not only from the rubble, but also the stone dressings of the buttresses and the remaining window masonry. This was done by applying an algacide and then steam cleaning. It was very surprising to see how bad the state of the stonework was to both the buttresses and windows. The appearance was rather pink and we wondered if there had been a fire. The condition was such that stone piece repairs were required by the masons as well as general repointing. Furthermore, additional nano-lime consolidation, micro-filling of fractures, and mortar repairs were also necessary by a specialist conservator, who also restored the profiles to the window masonry so they could properly shed water once again.

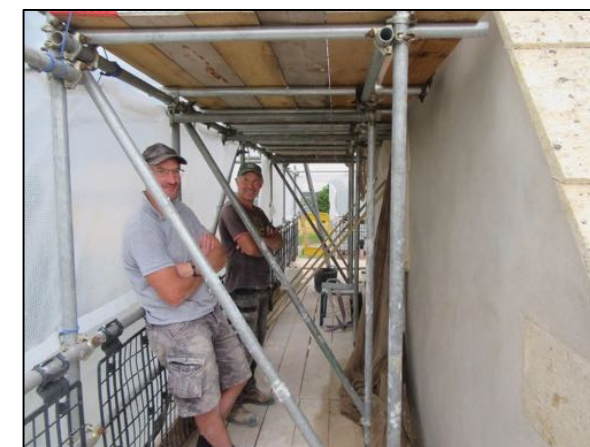
Master plasterer, Roy Cafferty, about to apply a sample area

The challenge was to find a contractor who was capable of producing and applying such a render. Fortunately the stone masons who had carried out the east window were up for a challenge and with the assistance of a septuagenarian master plasterer they learnt more about producing complex hot mixed mortars and how to apply them. The mortar for the render contained chalk and limestone sand, as well as hair to the base coats and extra grit before being laid down for a few days to fatten up and reduce shrinkage. A dubbing coat was applied with pinnings to bring the uneven walling more level before two coats of render were applied, conforming to be approved sample.
