Case study: May Street Presbyterian Church, Belfast

Roof project at May Street Presbyterian Church, completed January 2018

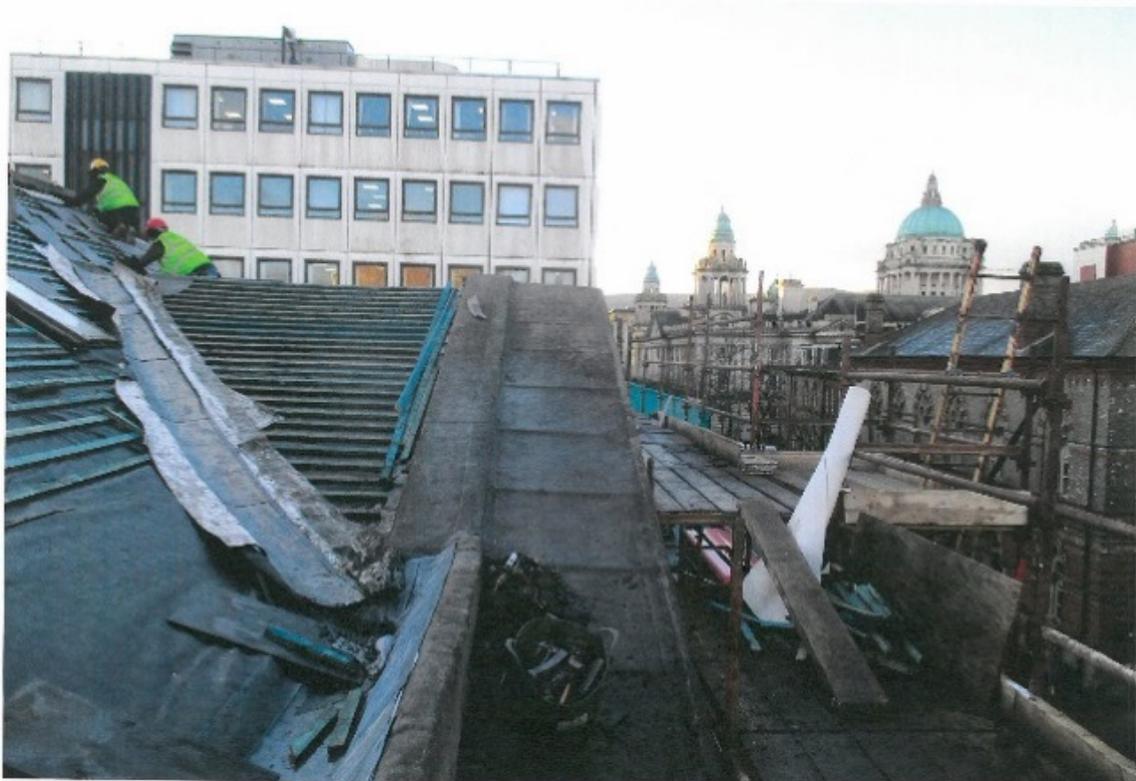
The issues: Felt parapet wall gutters and valleys were installed in the 1960s and had reached the end of their life. This caused multiple failures around the perimeter walls. Professional reports showed that the flat roof top was in good order, but the slated perimeter had many slipped, broken or damaged slates. Ingress of water was evident in several places together with damage to plasterwork and decoration. The fine Binns organ which was installed in 1914 was also threatened and there was a danger of dry rot affecting timbers and masonry. If water ingress continued the church would have had to close within a few months.

Project description: The project was to put up scaffolding, remove the slated perimeter together with the felt valleys and parapet gutters, and replace them with natural slate pitched roofing, lead valleys and lead parapet gutters. Natural slate and lead would have been the original materials. This will keep the church watertight, safe and open for use.

"The renewal of our roof, with 10,000 new Bangor Blue slates, means we can at last pack away the buckets and basins which have been catching the drips and leaks for years. Making the building watertight has been a long cherished ambition."
